# Manhole Inspection Summary

Manhole # S41EE\_026MH

Insp Date: **1/9/08 3:39 PM**

**Location** Address: **1112 EDEN ST**

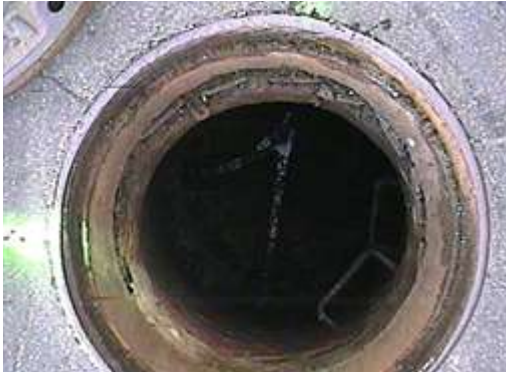
Defect 1

Offset: **1** (in.)

FRAME OFFSET

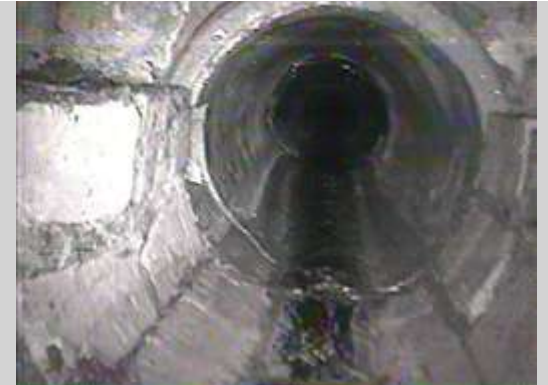
12 O'Clock Outflow

8 in. Circular Gravity Sewer  
Pipe Out @ 12 O'Clock

Pipe Material: **Clay** ☐ Pipe Lined

Invert Depth: **9.24** (ft.) Flow Characteristics: **Slow**

Deposits: ☒ None ☐ Mud ☐ Sludge ☐ Debris ☐ Grease

Infiltration: **None** Pipe Seal Cond: **Sound**

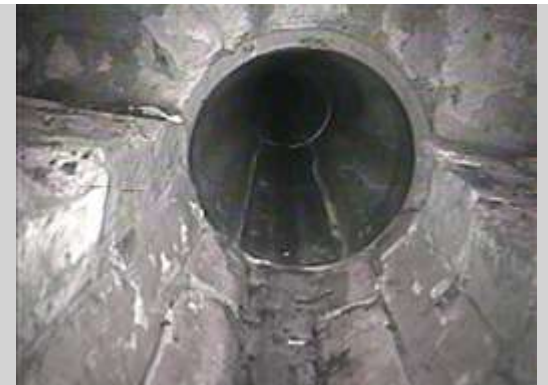
6 O'Clock Inflow

8 in. Circular Gravity Sewer  
Pipe In @ 6 O'Clock

Pipe Material: **Clay** ☐ Pipe Lined

Invert Depth: **9.23** (ft.) Flow Characteristics: **None**

Deposits: ☒ None ☐ Mud ☐ Sludge ☐ Debris ☐ Grease

Infiltration: **None** Pipe Seal Cond: **Sound**

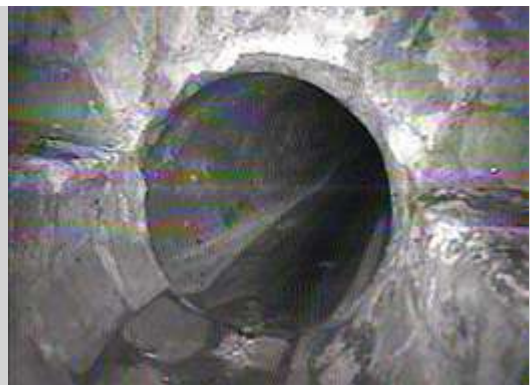
9 O'Clock Inflow

8 in. Circular Gravity Sewer

Pipe In @ 9 O'Clock

Pipe Material: **Clay** ☐ Pipe Lined

Invert Depth: **9.23** (ft.) Flow Characteristics: **Slow**

Deposits: ☒ None ☐ Mud ☐ Sludge ☐ Debris ☐ Grease

Infiltration: **None** Pipe Seal Cond: **Sound**

Connects To: **Dead End**
